**Project Name:** MHA Renovations and Repairs for MHA Housing at Montgomery Plaza  
**Project Address:** 1395 Pennsylvania Street, Memphis, Tennessee 38106  
**Project Number:** 21640920  
**Observation Date:** 03/08/2023

The above referenced project assessment site was attended by SSR to observe the existing condition of multiple units located at the MHA Montgomery Plaza Neighborhood. The unit comments are listed in the respective description associated with each photo. See Appendix A for approximate locations of pictures taken in each unit. All corrective actions shall be completed by the contractor as indicated. The items below are the deficiencies noted as well as the corrective actions to be taken:

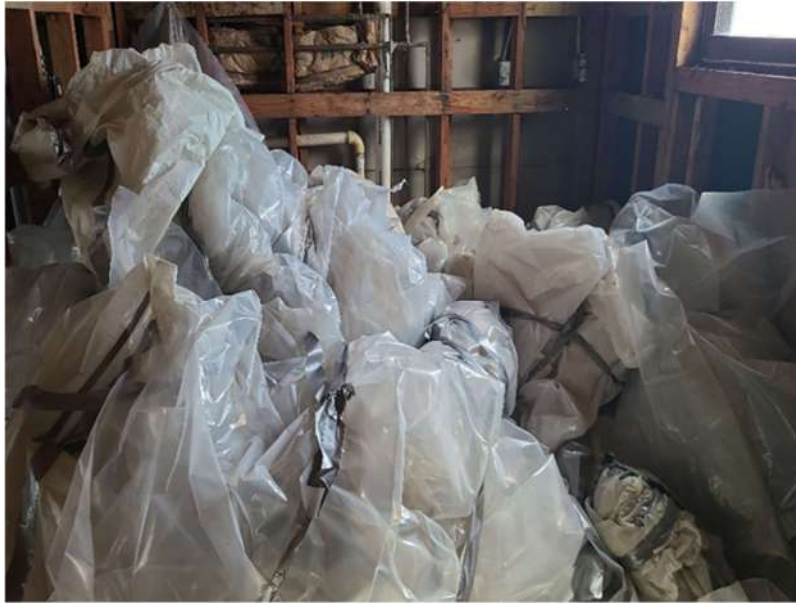
Photo 1: Unable to inspect kitchen area due to large presence of debris.

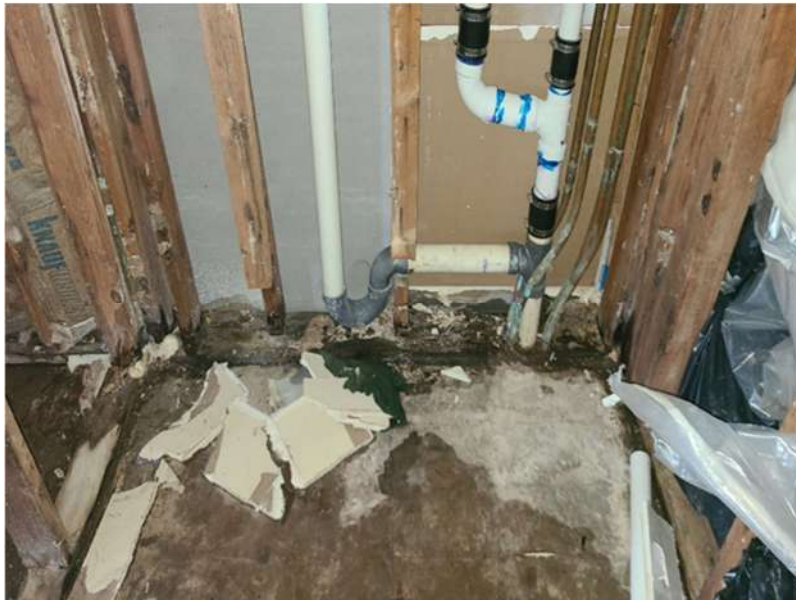
Photo 2: Lower framing adjacent to kitchen is rotten. Standing water present.

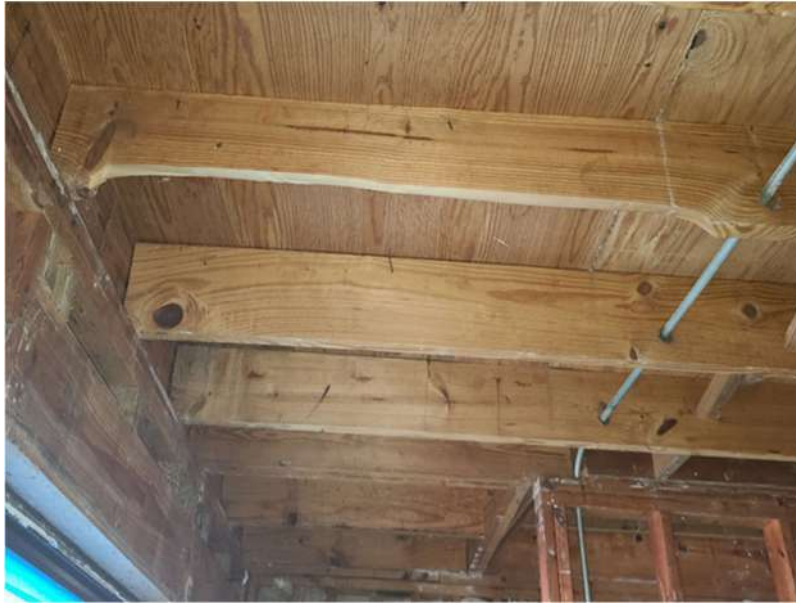
Photo 3: Section of floor joist missing.

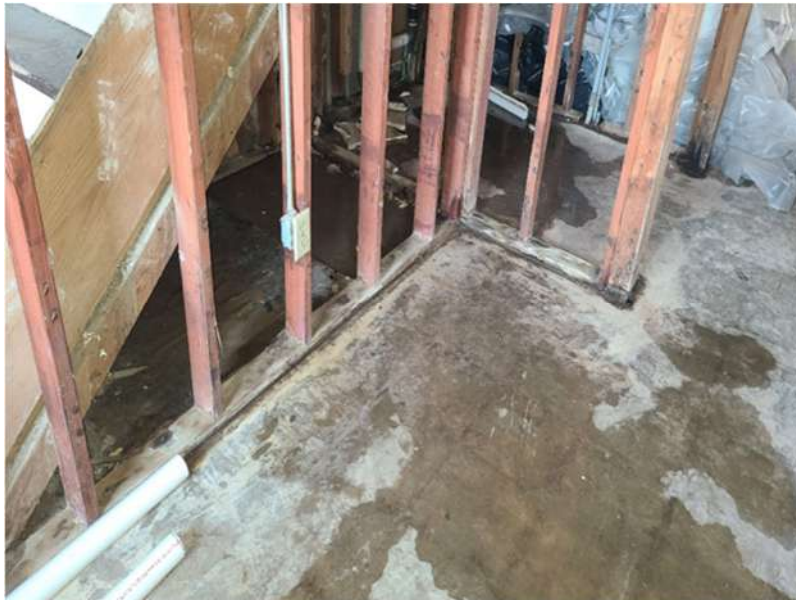
Photo 4: Lower living room framing is rotten. Standing water present.

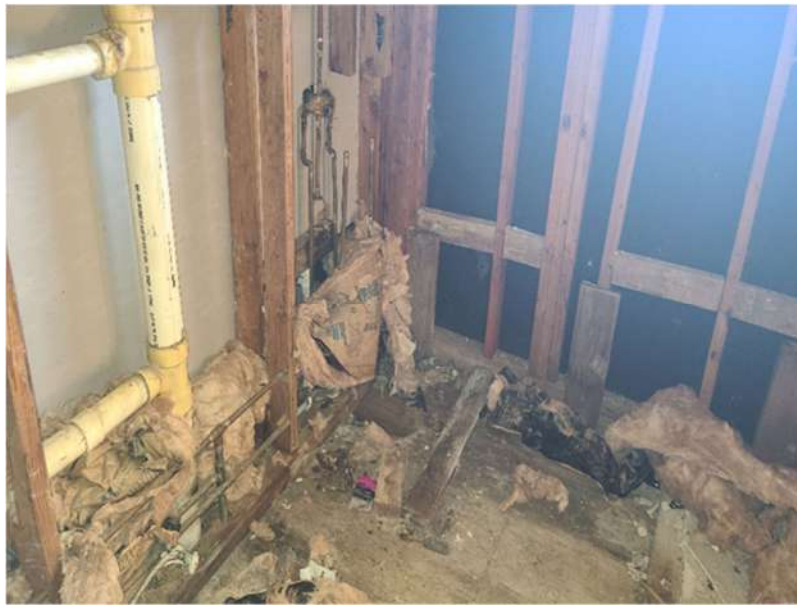
Photo 5: Lower framing and plywood in second floor bathroom is rotten.

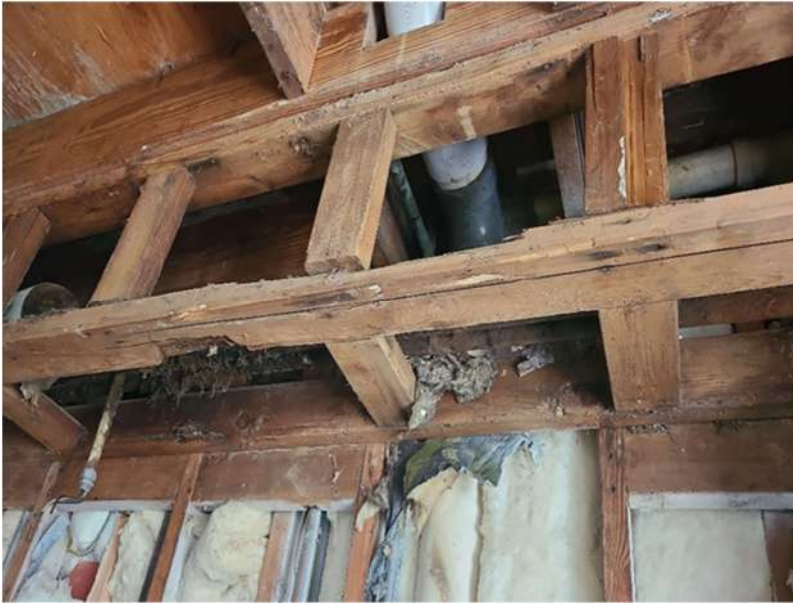
Photo 1: Upper framing in the kitchen is rotten.

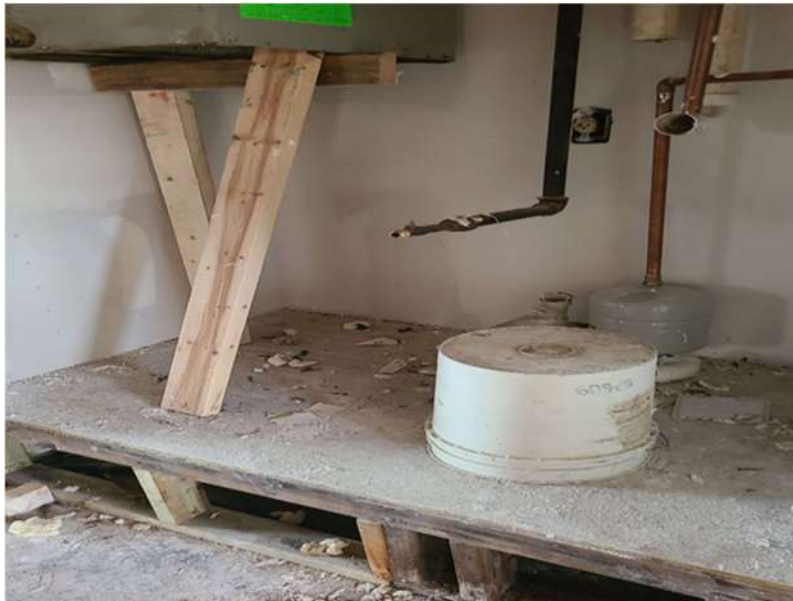
Photo 2: Plywood under hot water heater was replaced.

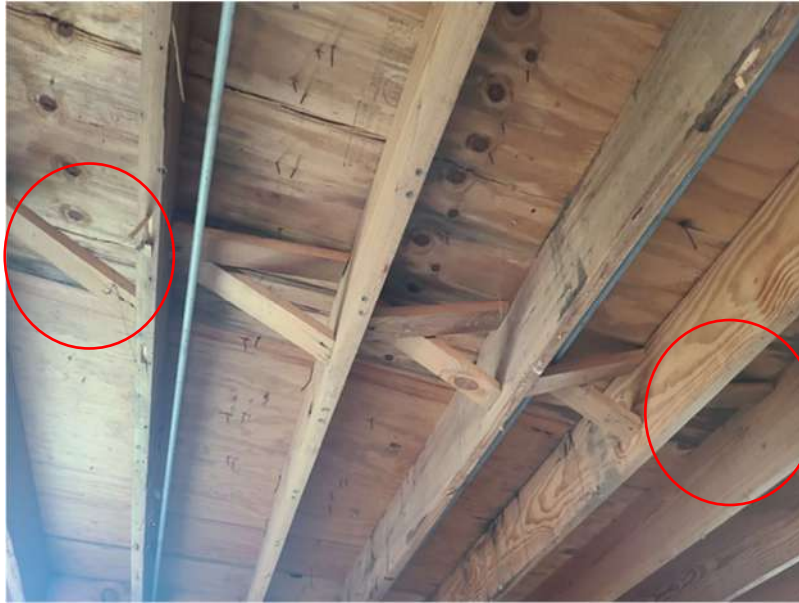
Photo 3: Cross bracing between joists missing in two spots.

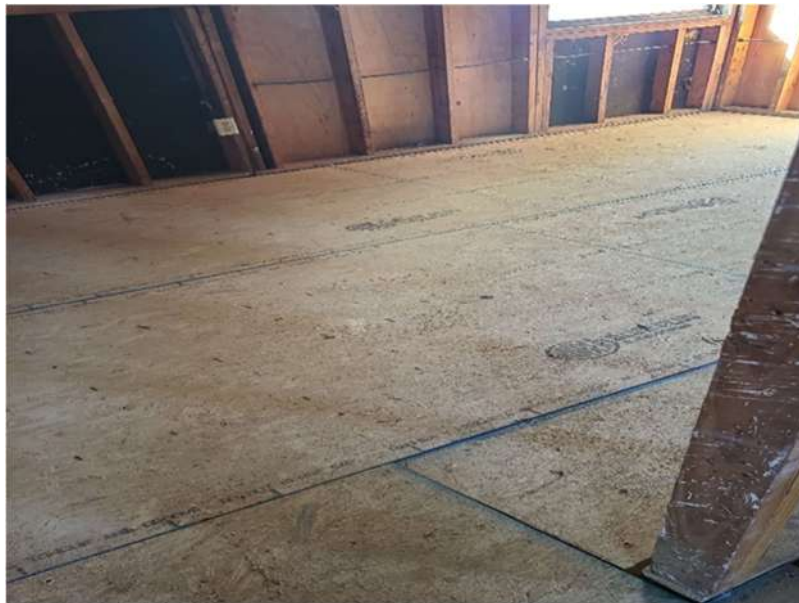
Photo 4: New sub-flooring installed on the second floor.

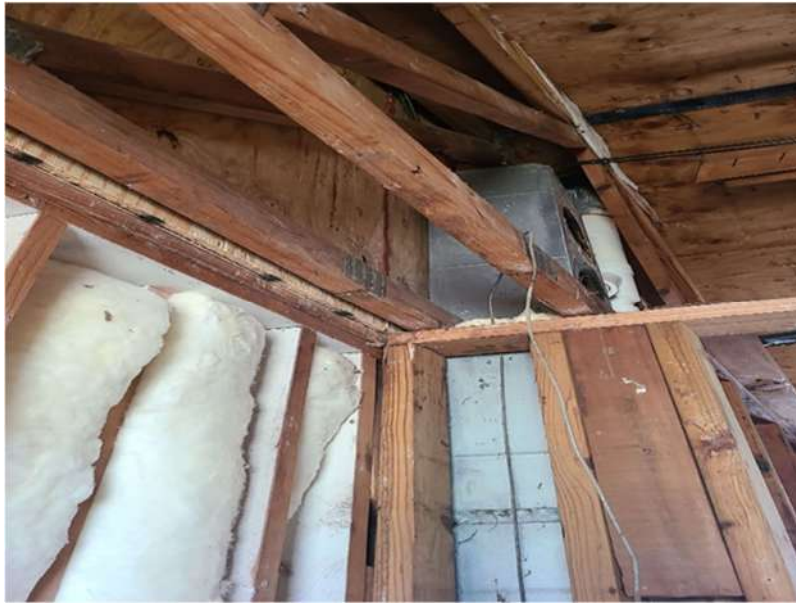
Photo 5: Bottom chord of truss is cut.

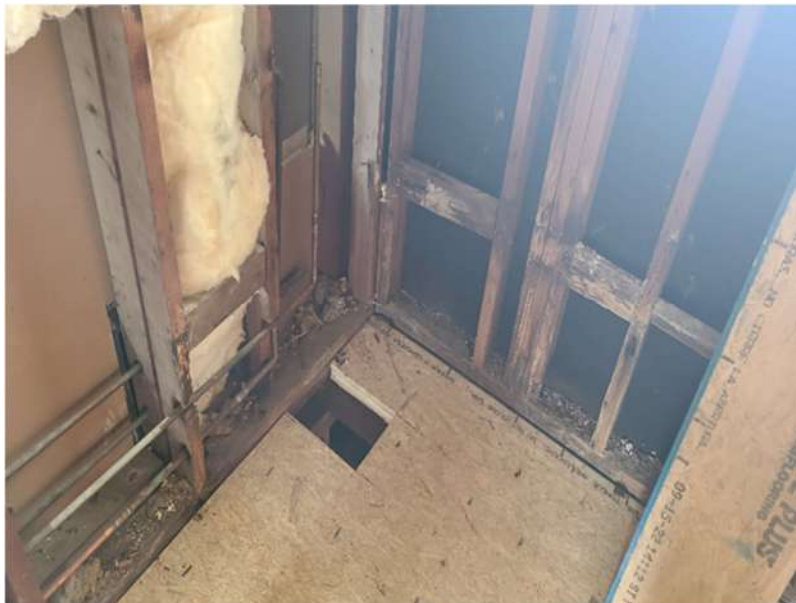
Photo 6: Lower framing in second floor bathroom is rotten.

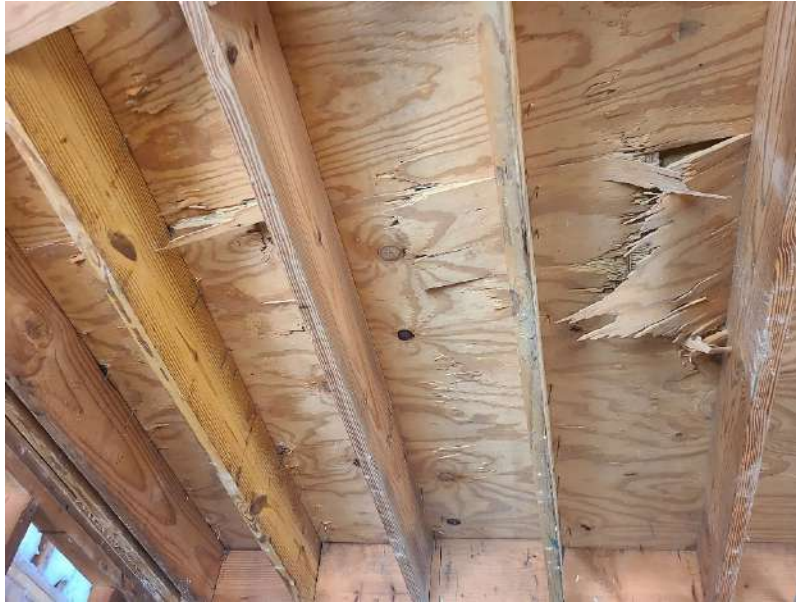
Photo 1: Plywood on second floor is broken.

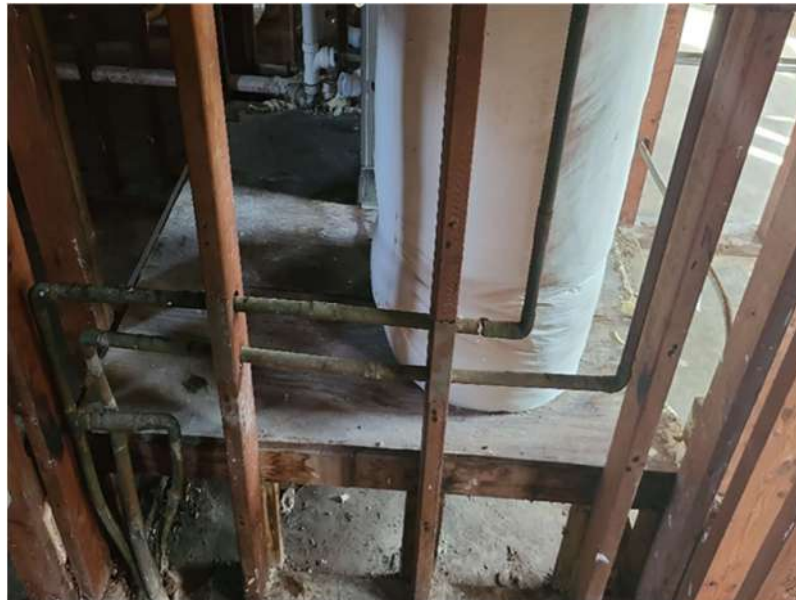
Photo 2: Framing and plywood under hot water heater is rotten.

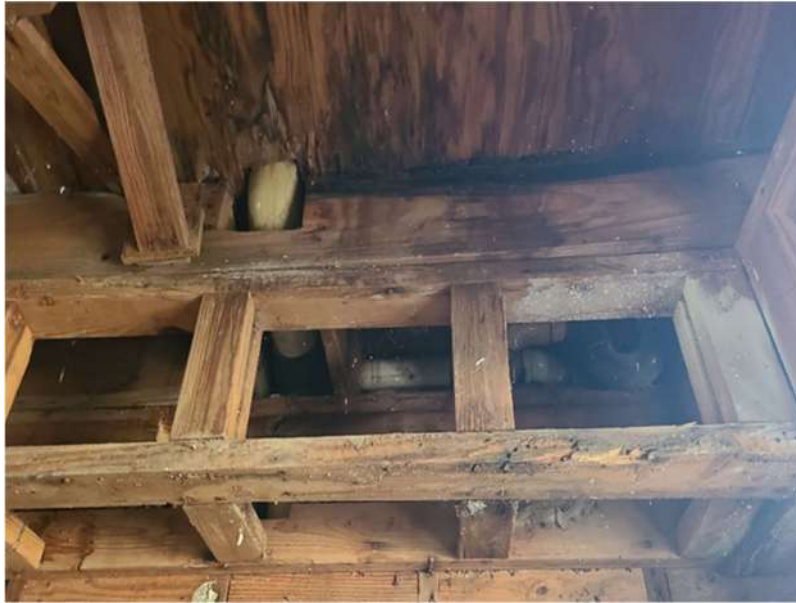
Photo 3: Upper framing and plywood above kitchen area is rotten.

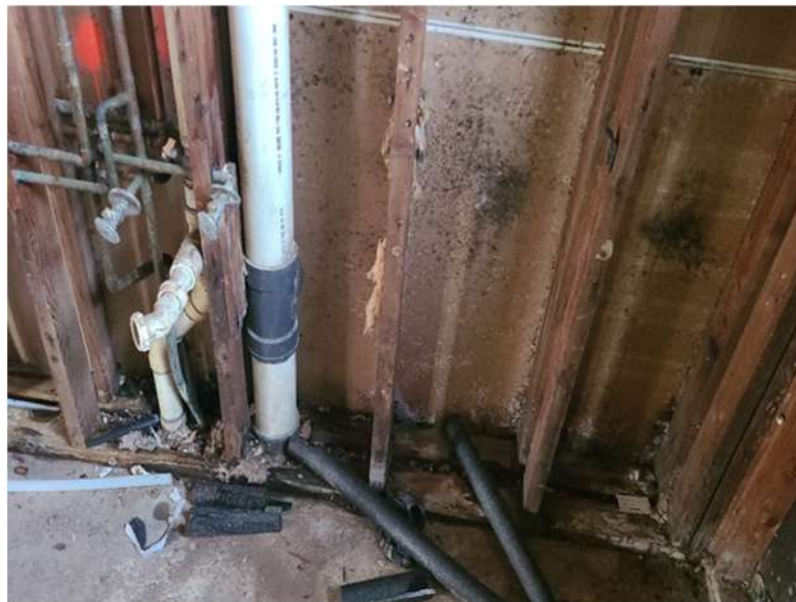
Photo 4: Lower framing in kitchen area is rotten

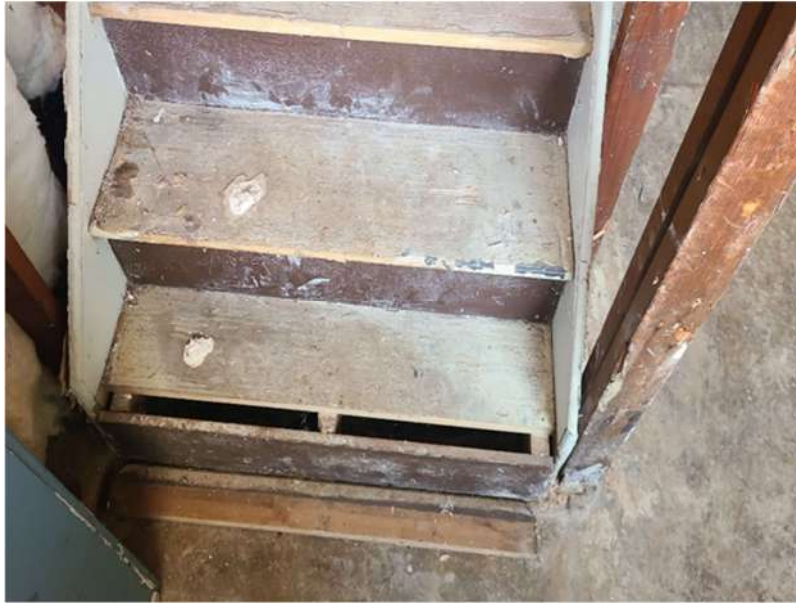
Photo 5: Broken stair tread.

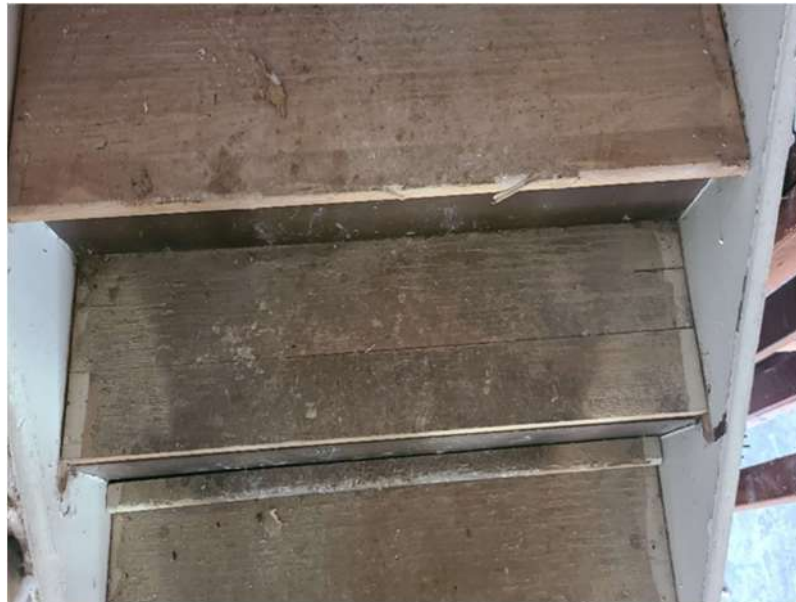
Photo 6: Broken Stair tread.

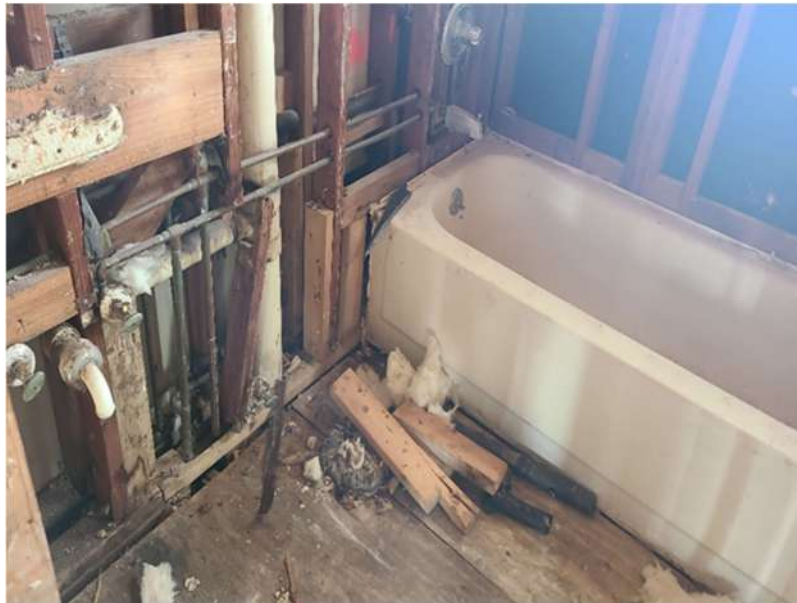
Photo 7: Framing around the bathtub has been partially replaced. Judging from the rotten framing in the kitchen below, further framing will likely need to be replaced behind the bathtub.

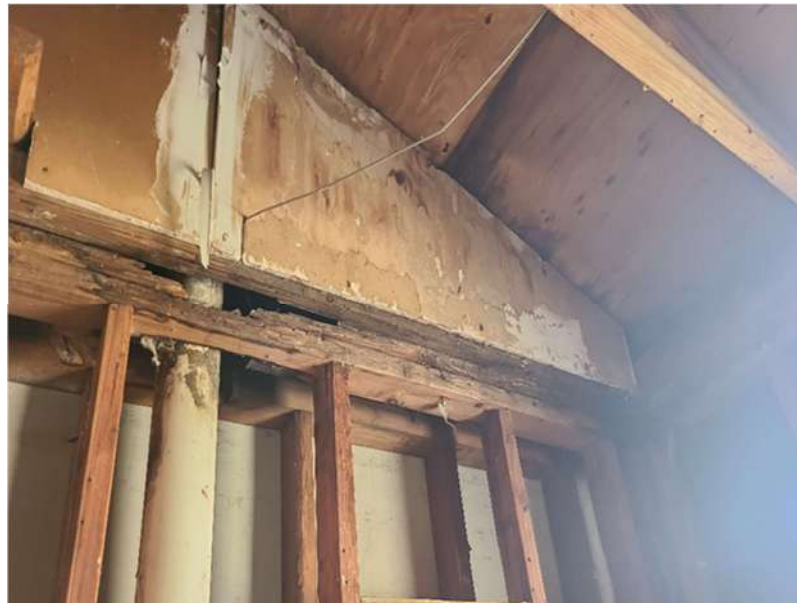
Photo 8: Upper framing in bathroom area is rotten.

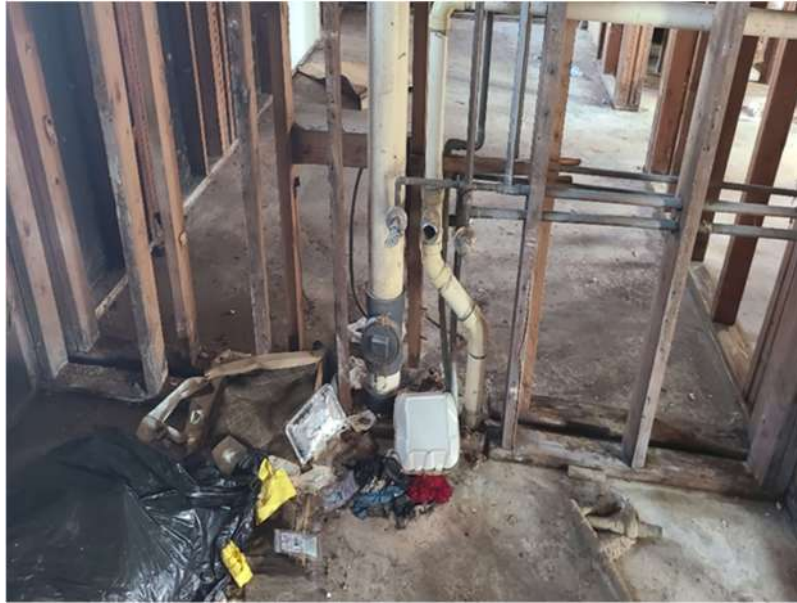
Photo 1: Lower framing in kitchen area is rotten.

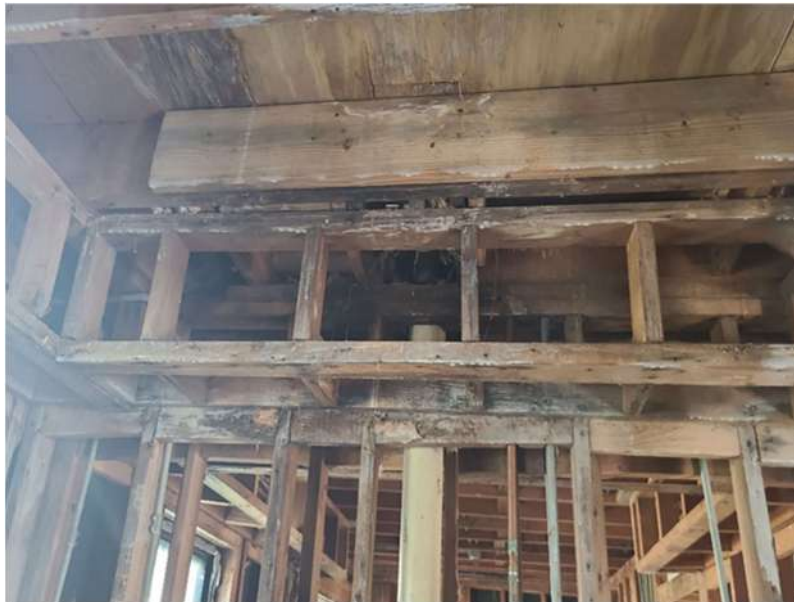
Photo 2: Upper framing in kitchen area is rotten.

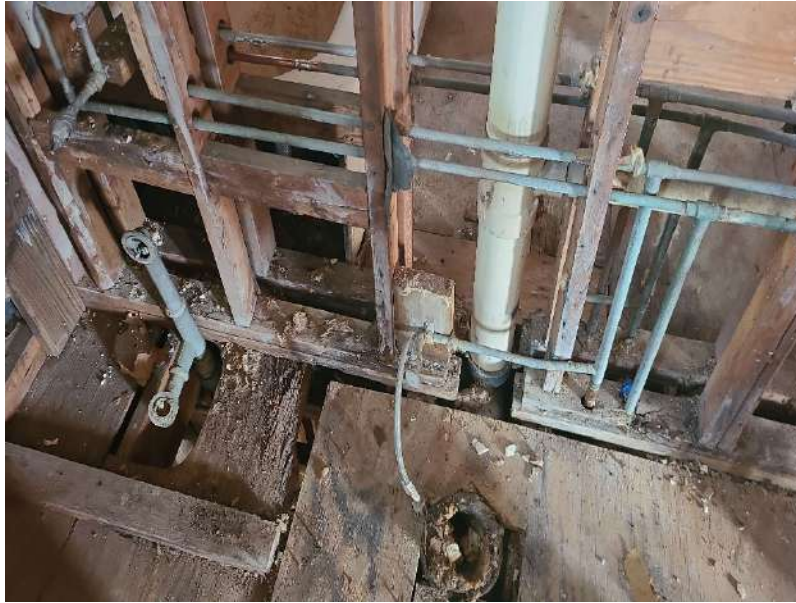
Photo 3: Lower framing and plywood in the 2<sup>nd</sup> floor bathroom area is rotten.

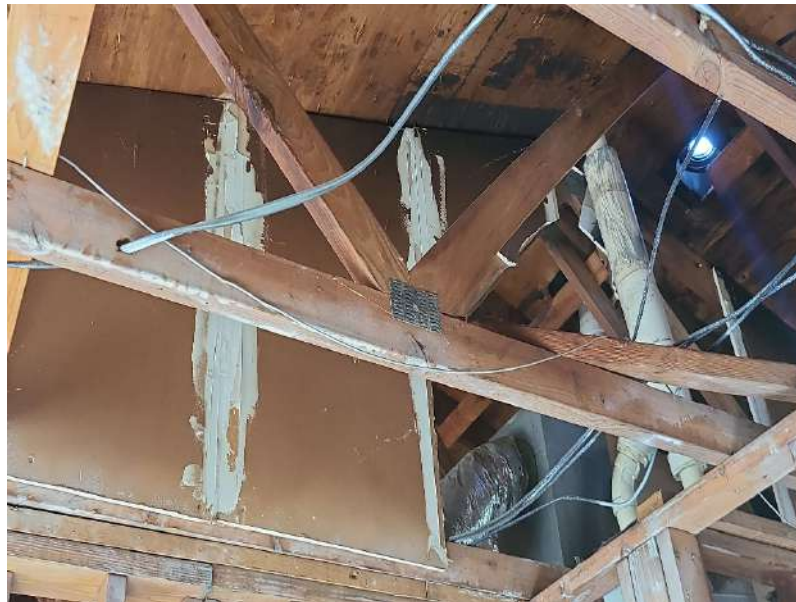
Photo 4: Truss chord splitting at splice plate.

Item	Description	Action Required
1	<p>Cracked bottom chord of truss supporting roof.</p> <p>This problem was present in the following units: <a href="#">1409 Tumberland Unit 2</a></p>	<p>Sister the bottom chord for the entire length of the crack, extend past the crack to nail to adequate material. See detail 2.</p>
2	<p>Water damage at kitchen and bathroom, especially near plumbing or active leaks. This includes miscellaneous rotten wood at the floor level or stud walls.</p> <p>This problem was present in the following units: <a href="#">61 West Olive Unit 1</a>, <a href="#">65 West Olive Unit 2</a>, <a href="#">1411 Tumberland Unit 1</a>, <a href="#">1409 Tumberland Unit 2</a>, <a href="#">1409 Tumberland Unit 1</a> and <a href="#">1398 Kansas, Unit 1</a></p>	<p>Replace rotten wood at kitchen and bathroom (especially near plumbing), replace sills, studs, flooring, or joists as required due to water damage. Replace with "in kind" wood members to match existing. If floor joists are damaged replace or sister for entire length of span, see detail 1.</p>

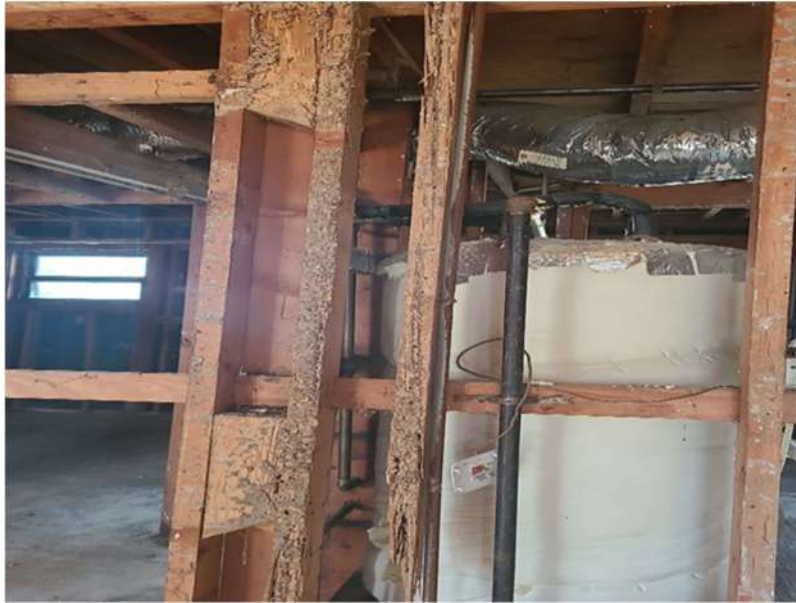
Photo 1: Evidence of termite damage in wall studs near the hot water heater.

11	<p>Termite damage found in some wall framing members.</p> <p>This problem was present in the following unit: <a href="#">1409 Tumberland Unit 1</a></p>	<p>Damaged members to be replaced.</p>

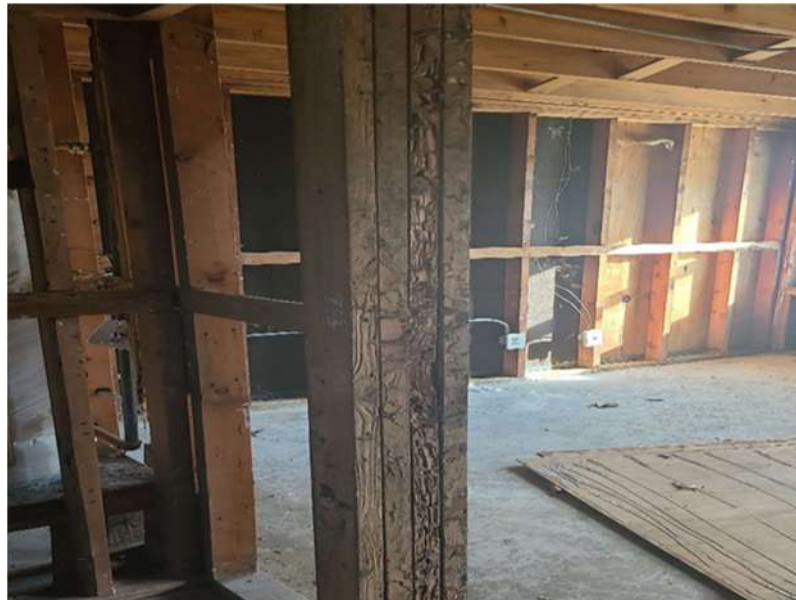
Photo 2: Termite damage.

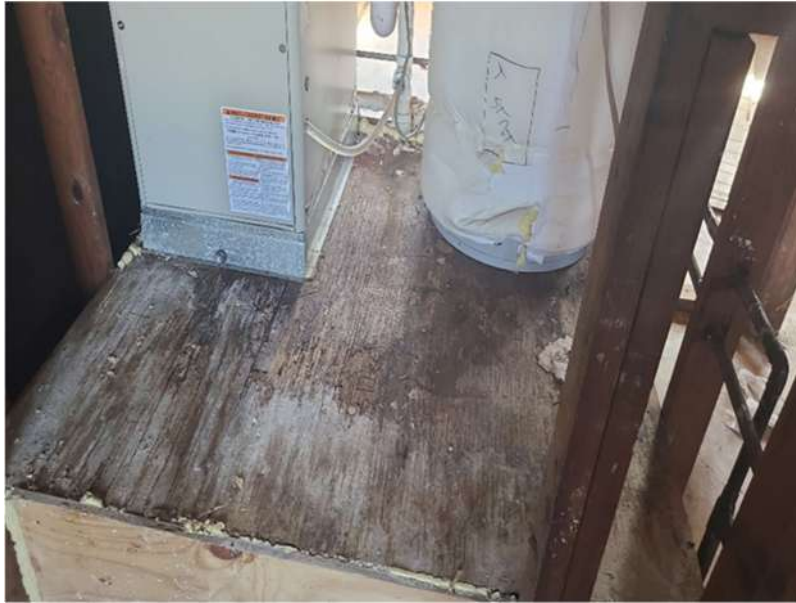
Photo 3: Plywood under hot water heater is rotten.

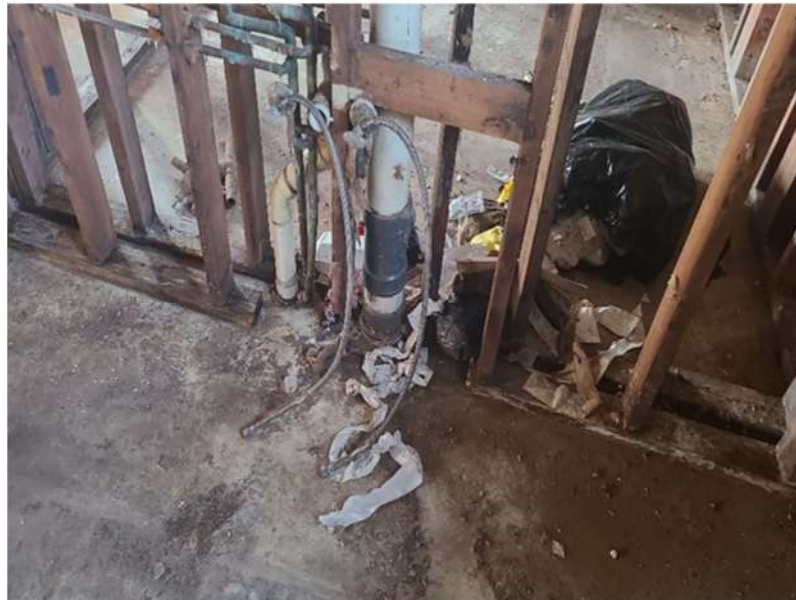
Photo 4: Lower framing in kitchen area is rotten.

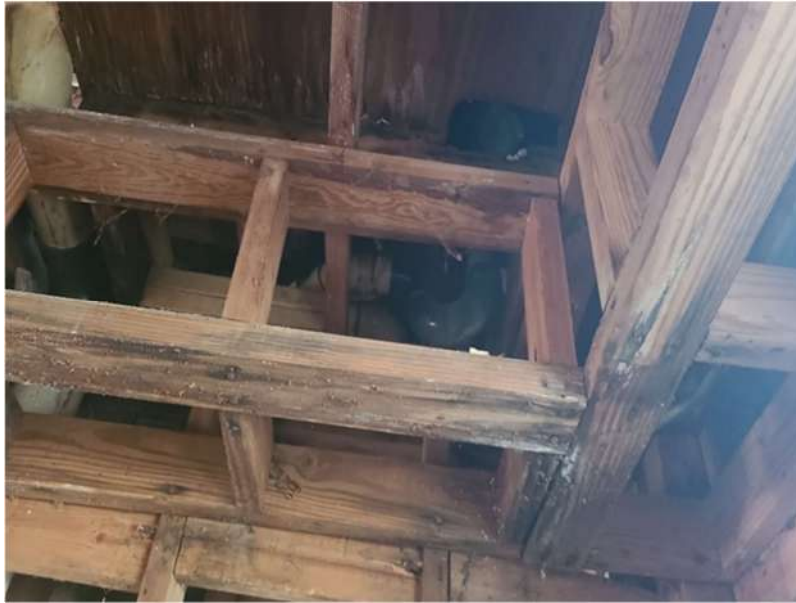
Photo 5: Upper framing in kitchen area is rotten.

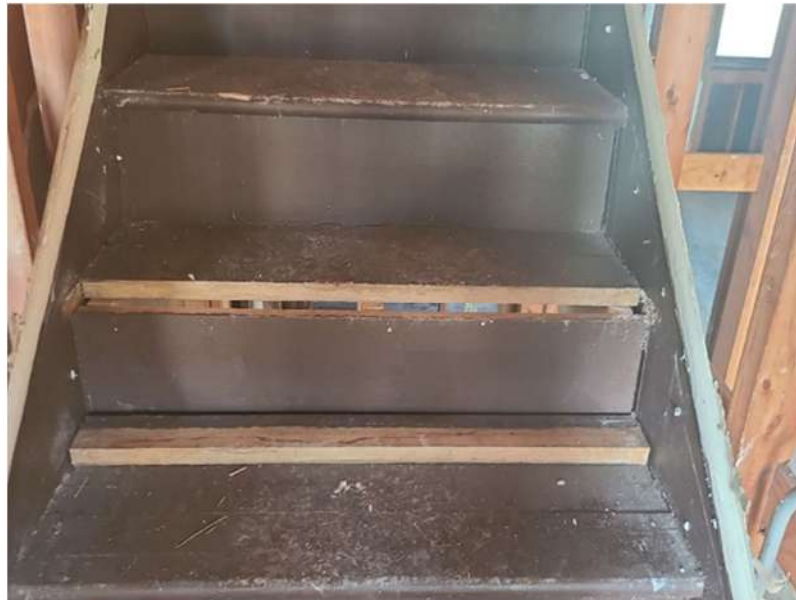
Photo 6: Broken stair tread.

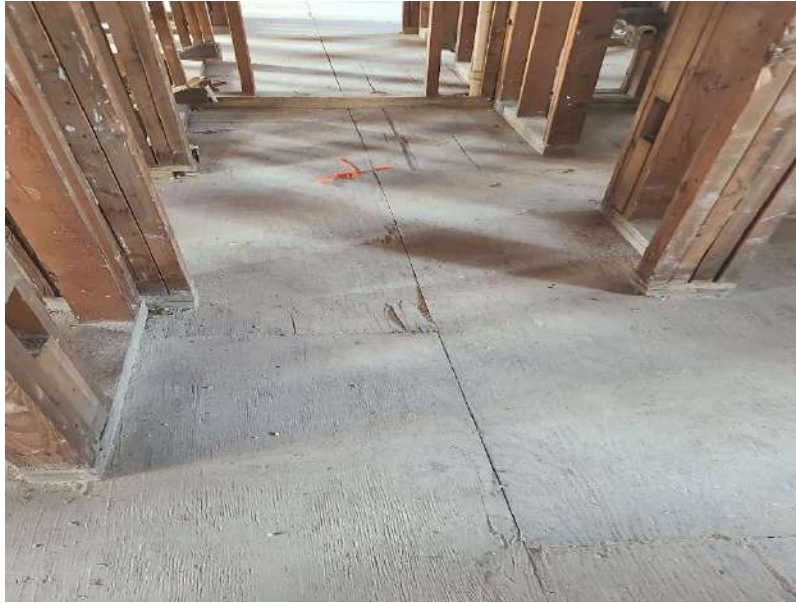
Photo 7: Plywood on second floor was broken in multiple areas.

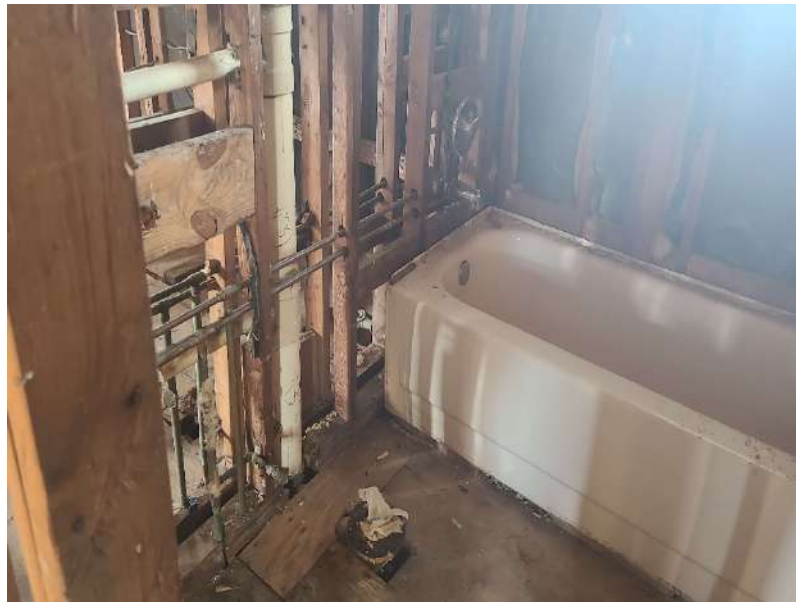
Photo 8: Lower framing in upstairs bathroom is rotten.

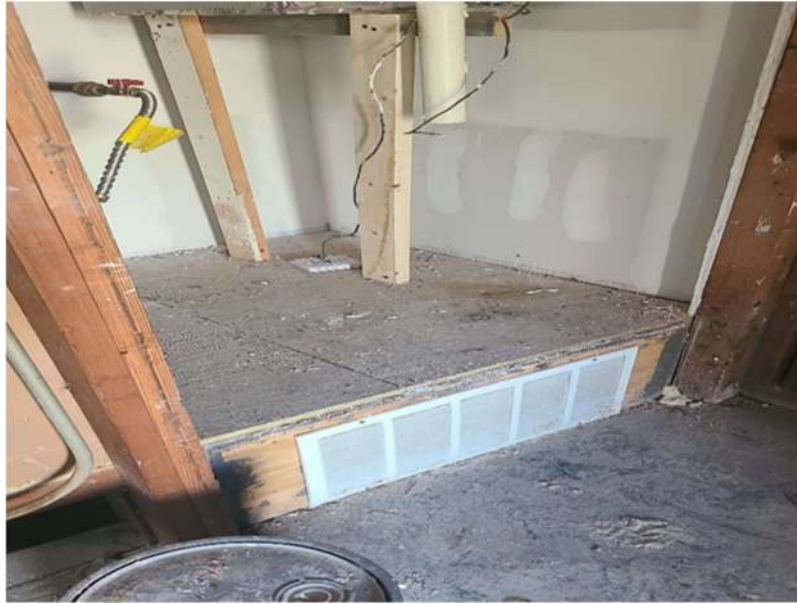
Photo 1: Hot water heater framing has been replaced. Drywall has been installed.

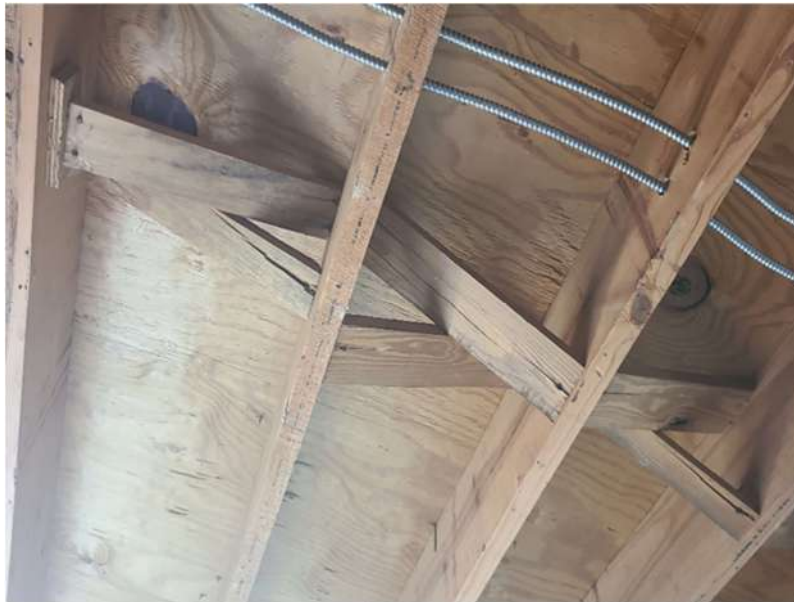
Photo 2: Floor joist cross bracing is cracked.

3	<p>Bracing between the floor joists are not connected or cracked.</p> <p>This problem was present in the following units: <a href="#">65 West Olive Unit 2</a> and <a href="#">1398 Kansas Unit 1</a></p>	<p>Reattach bracing to floor joists and replace cracked bracing.</p>
4	<p>Splitting/cracked and settling joists supporting second floor.</p> <p>This problem was present in the following unit: <a href="#">61 West Olive Unit 1</a></p>	<p>If second-floor flooring is to be replaced, the joists shall be replaced in kind while the flooring is removed. If the second-floor flooring is to remain, raise the members to their original height and sister the member(s) for the entire length of the span. See detail 1.</p>

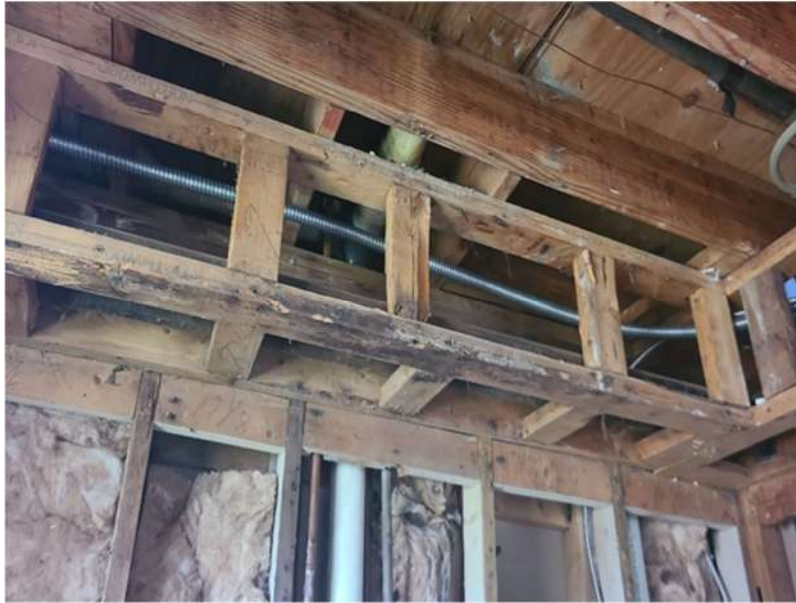
Photo 3: Upper framing in kitchen is rotten.

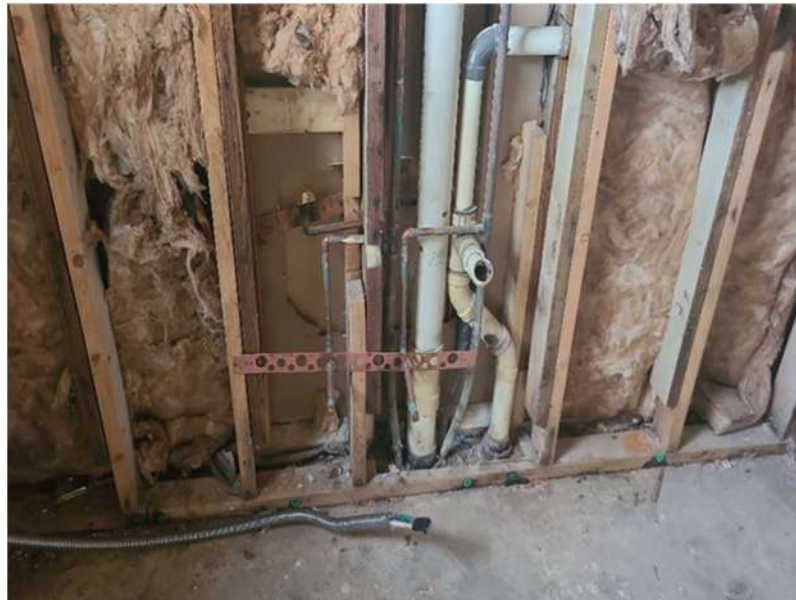
Photo 4: Lower wall framing has been replaced in kitchen area.

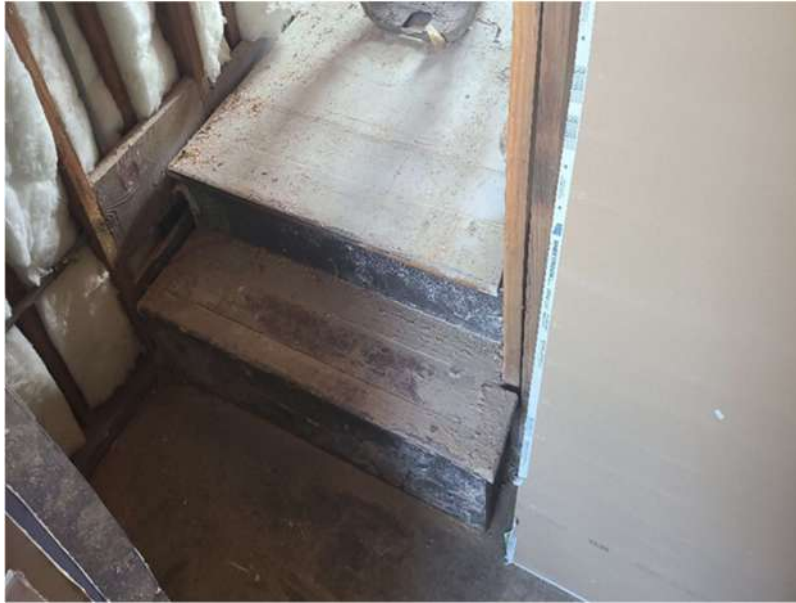
Photo 5: Broken stair tread.

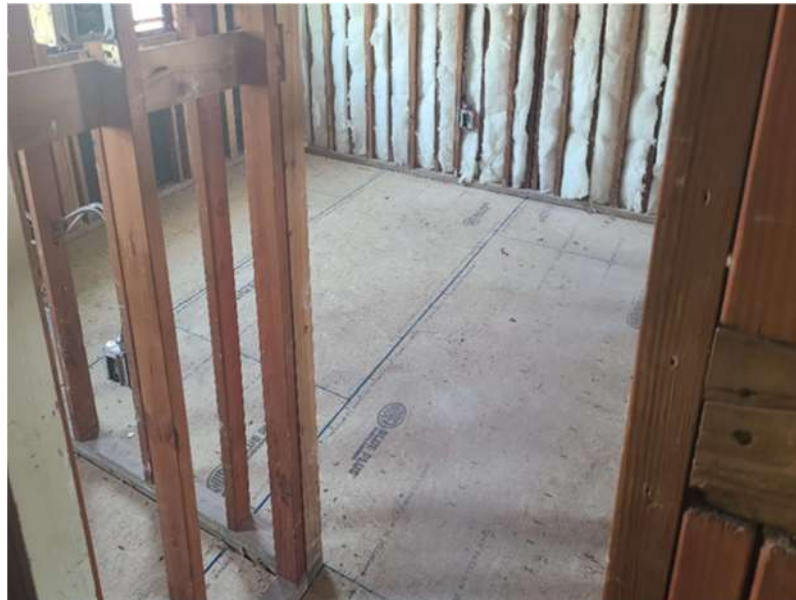
Photo 6: New subflooring has been installed on the second floor.

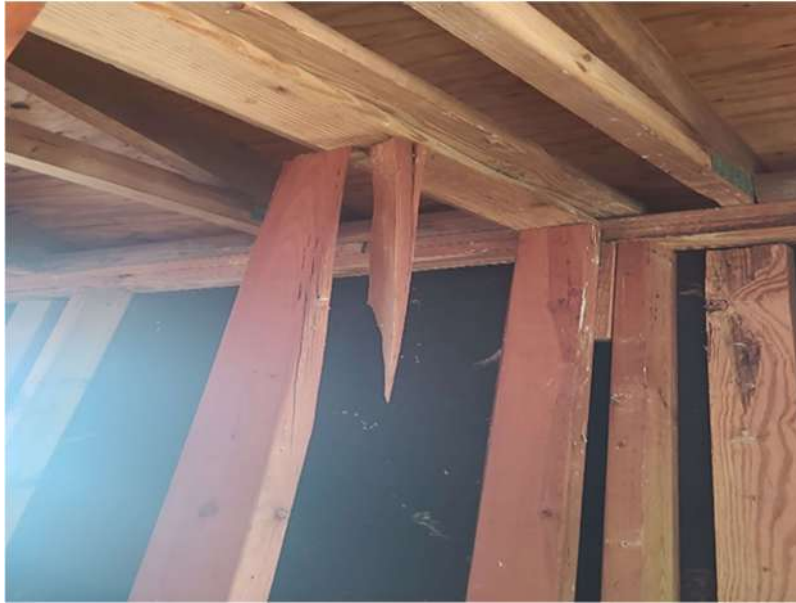
Photo 7: Wall stud broken off from top plate. Broken Member to be replaced.

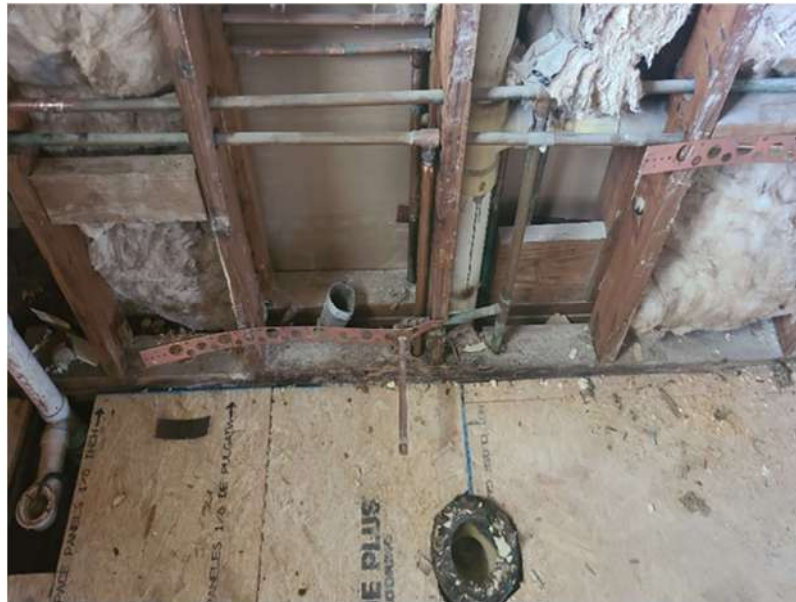
Photo 8: Lower framing in second floor bathroom is rotten.
