ADDENDUM NO. 1

Removal of Hazardous Materials at Kefauver Terrace

Asbestos Survey Report

**Kefauver Terrace – 7590, 7592, & 7534 Robinson Cove Units
Bartlett, Shelby County, Tennessee**

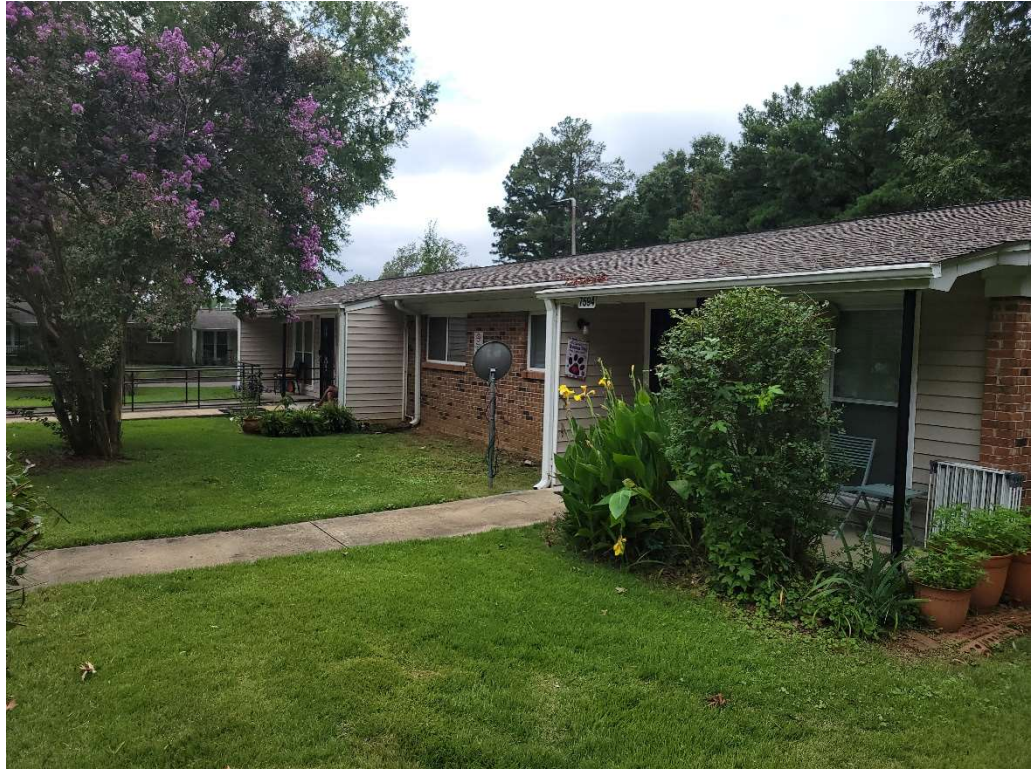
General View

Front Entrance

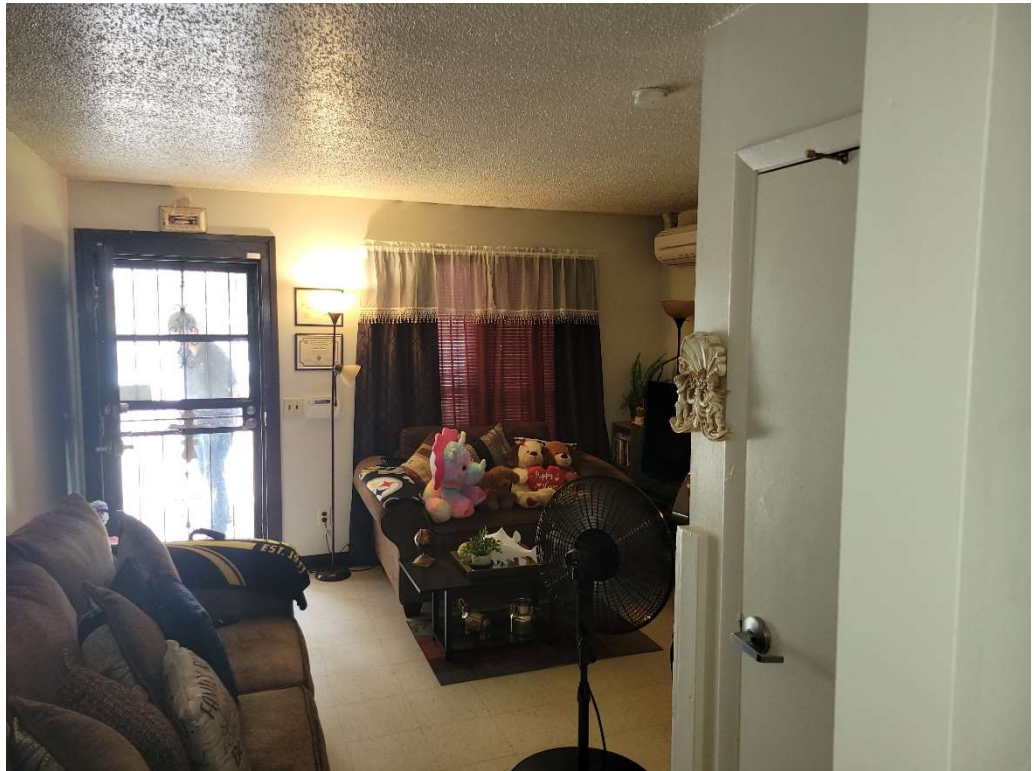
Photo # 2	Date: 07/19/2023
----------------------------	----------------------------

General View

Interior South Side Living Room

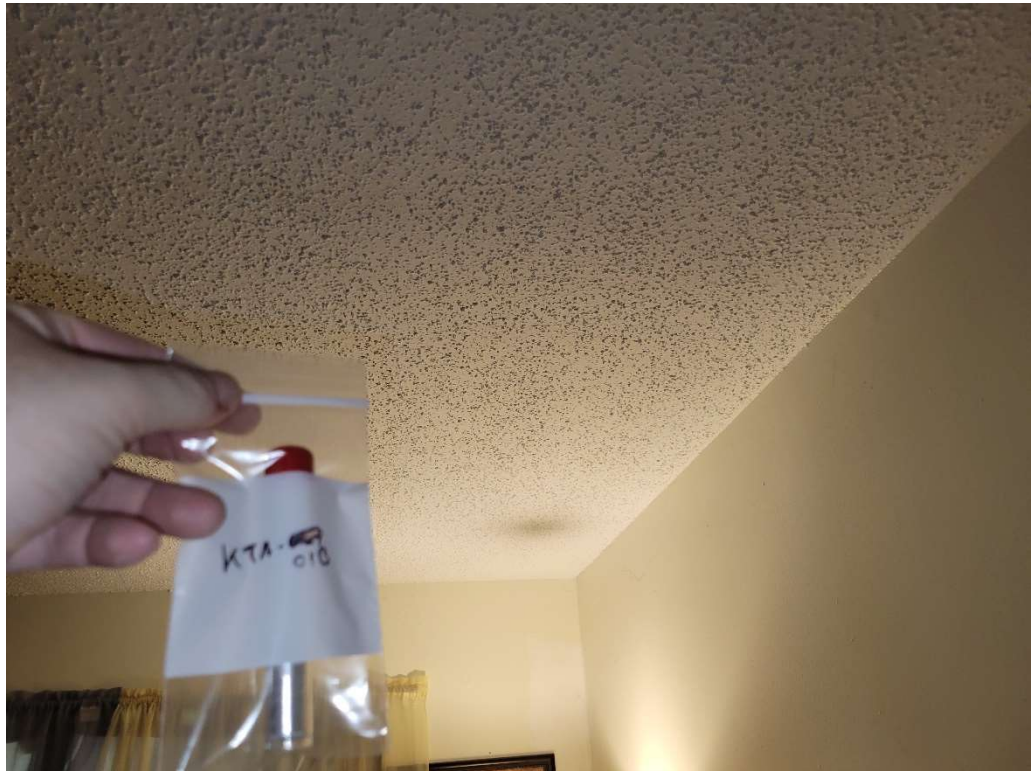
Photo # 3	Date: 07/19/2023
----------------------------	----------------------------

Asbestos Sample #
KTA-01

Ceiling Drywall with Popcorn Surface Texture

Tested Positive for Asbestos

- The asbestos containing ceiling drywall and popcorn complex that was identified throughout the facility is a friable material, observed to be in good condition. If this material becomes damaged, deteriorated, or will be disturbed by renovation activity, it must be abated by a licensed asbestos abatement firm asbestos abatement contractor prior to any renovation activity. These materials should be disposed of as asbestos containing waste at a landfill that accepts asbestos. Asbestos waste manifests should be kept for records.
- If suspect materials are identified behind walls, beneath floor tile or in any other accessible or inaccessible areas during renovation, additional testing should be performed to verify that these materials do not contain asbestos.

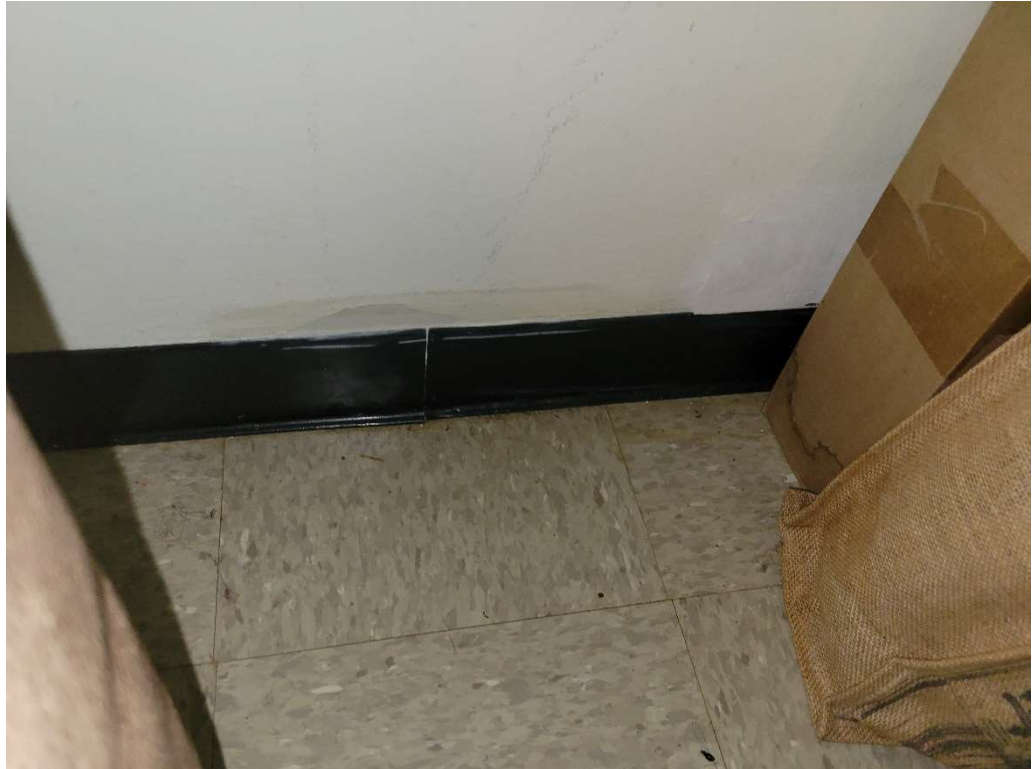
Photo # 5	Date: 07/19/2023
----------------------------	----------------------------

Asbestos Sample #
KTA-03

Cove Base with
Associated Mastic

Tested Negative for
Asbestos

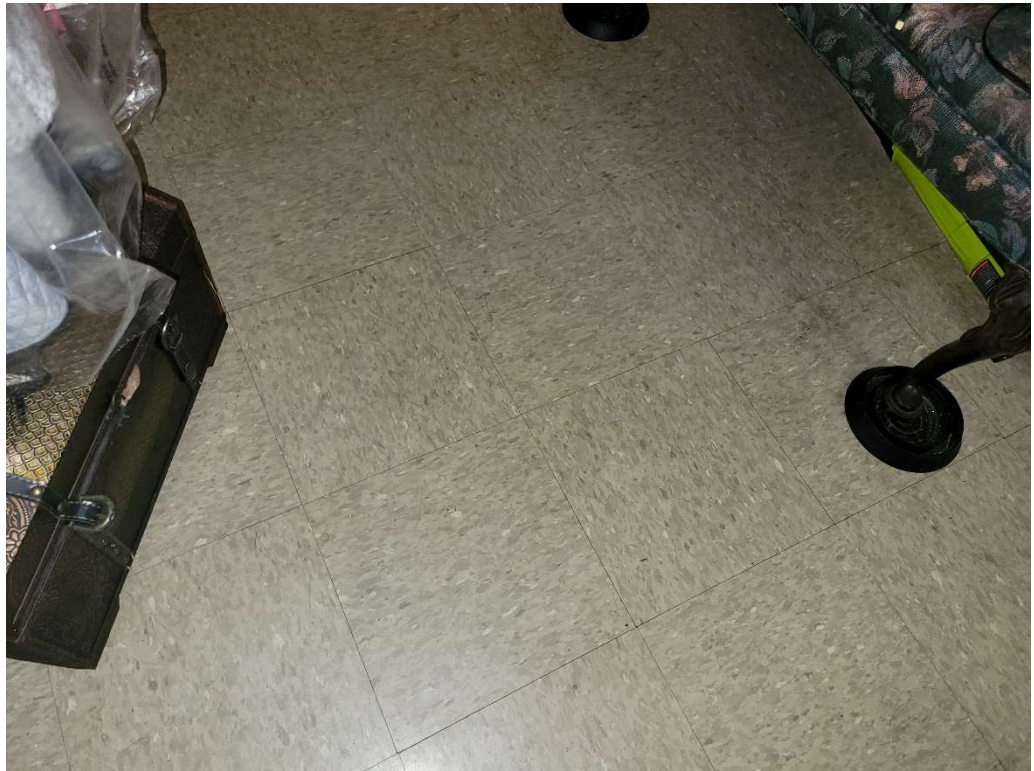
Photo # 6	Date: 07/19/2023
----------------------------	----------------------------

Asbestos Sample #
KTA-04

12x12 Vinyl Floor Tile
with Associated Yellow
Mastic

Tested Negative for
Asbestos
